# OVER AND UNDERWOOD HOME INSPECTION

**SAMPLE REPORT--Home Not Inspected by Over & Underwood Home Inspection**

<b>Date:</b> 7/29/2015	<b>Time:</b>	<b>Report ID:</b> Sample-2015
<b>Property:</b> 91142 East West Street Red Bud NC	<b>Customer:</b> Rosanna Danna	<b>Real Estate Professional:</b>

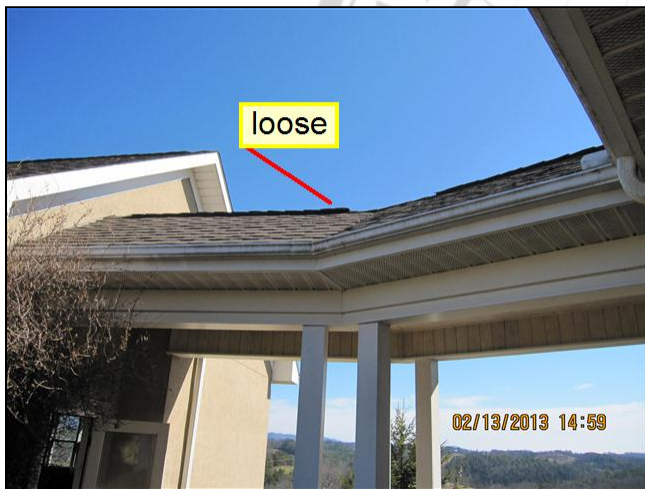
1.2 Item 1(Picture)

**1.2** Ridge vent loose at end above breezeway and needs to be fastened. Nail head used to fasten should be sealed with sealant.

Ridge vent loose at end above breezeway and needs to be fastened. Nail head used to fasten should be sealed with sealant.

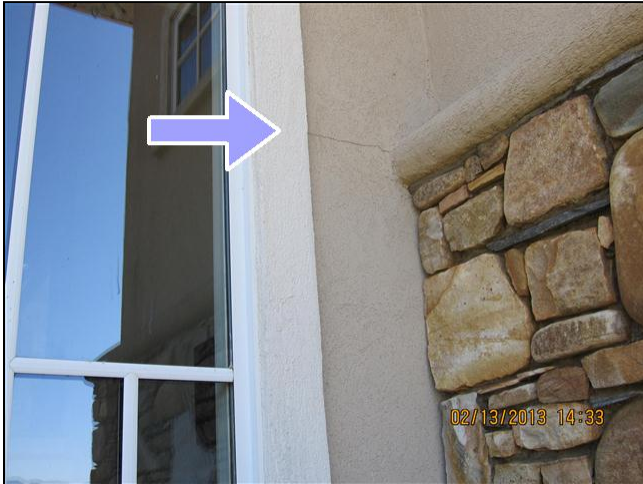
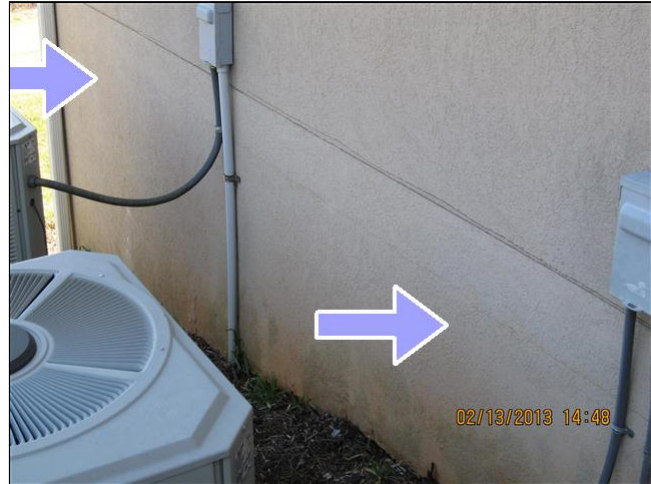
2.0 Item 1(Picture)

**2.0 (1)** Some hairline cracks in areas around home. These appear to be typical.

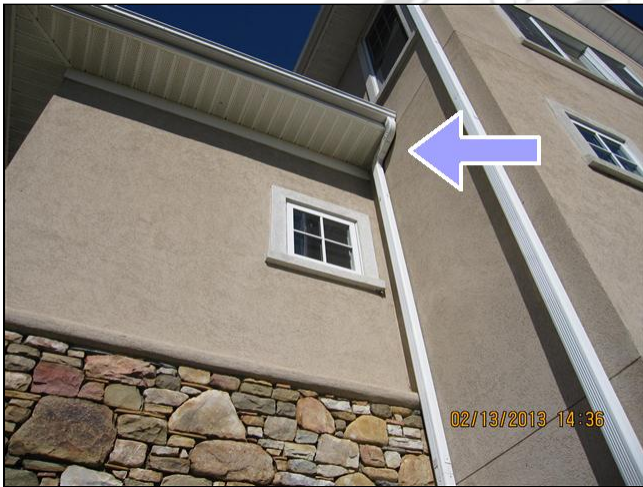
2.0 Item 3(Picture)

**2.0 (2)** Bird nest is wedged between downspout elbow and home should be removed and inspect further as animals can damage and allow water to get inside wall.

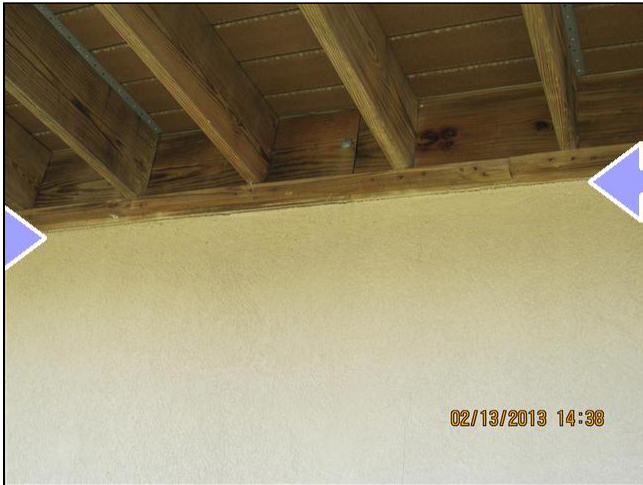
2.0 Item 4(Picture)

**2.0 (3)** A common seam where stucco and ledger meet under deck. I recommend silicone caulking to seal.

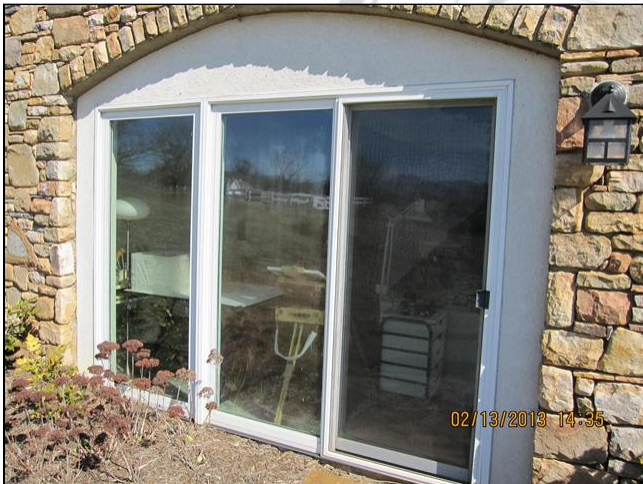
2.1 Item 1(Picture)

**2.1** Glass panel doors/window at right side (facing front) cloudy or seal is broken. Glass panes that have lost their seal (cloudy) can usually be replaced without replacing the entire unit. A qualified contractor should inspect and repair as needed.

Glass panel doors/window at right side (facing front) cloudy or seal is broken. Glass panes that have lost their seal (cloudy) can usually be replaced without replacing the entire unit. A qualified contractor should inspect and repair as needed.

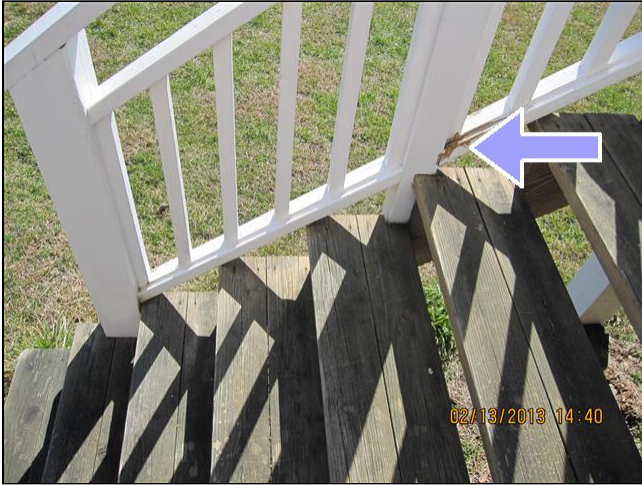
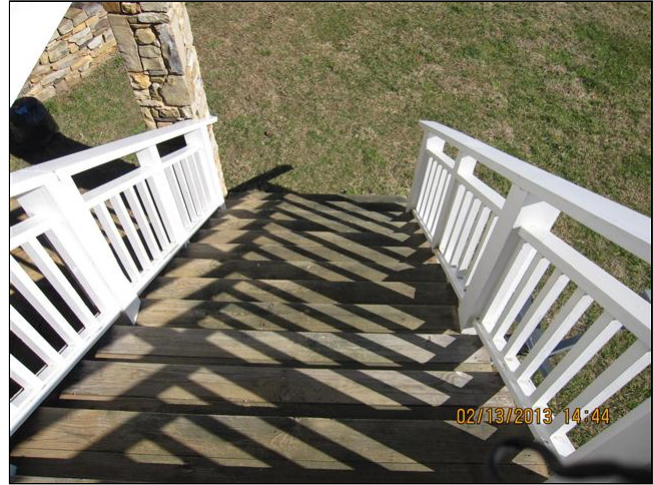
2.3 Item 1(Picture)

**2.3** Bottom rail is soft or deteriorated in one area and other areas weathered. Needs prep and paint. Deck stairs need algae removed with a cleaner and seal with a non skid weather sealant.

Bottom rail is soft or deteriorated in one area and other areas weathered. Needs prep and paint. Deck stairs need algae removed with a cleaner and seal with a non skid weather sealant.

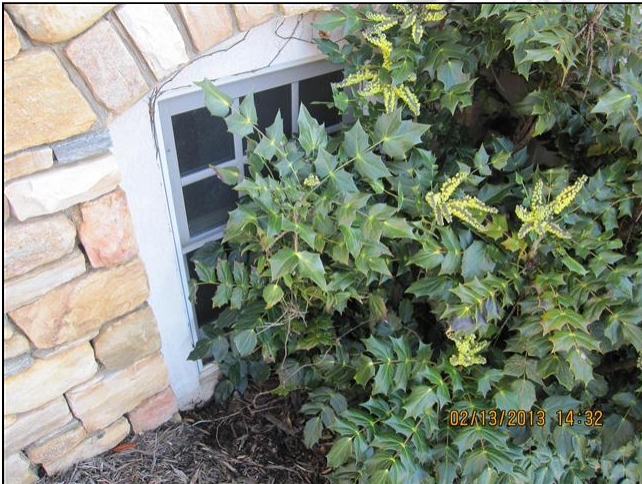
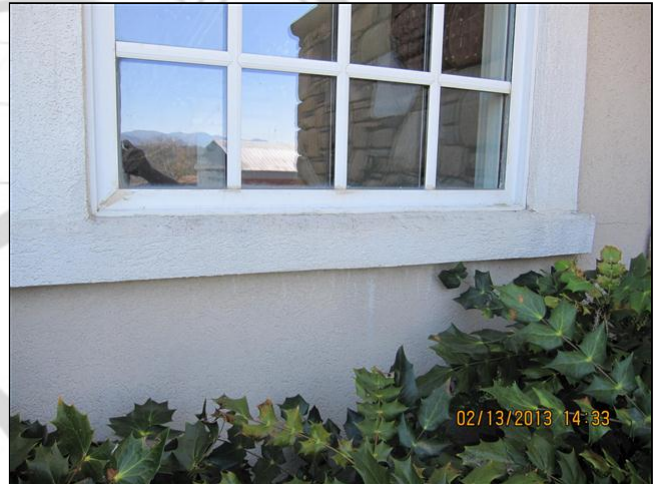
2.4 Item 1(Picture)

**2.4** Thorny bushes or vegetation obstructing access and should be relocated to allow clearance from siding of home

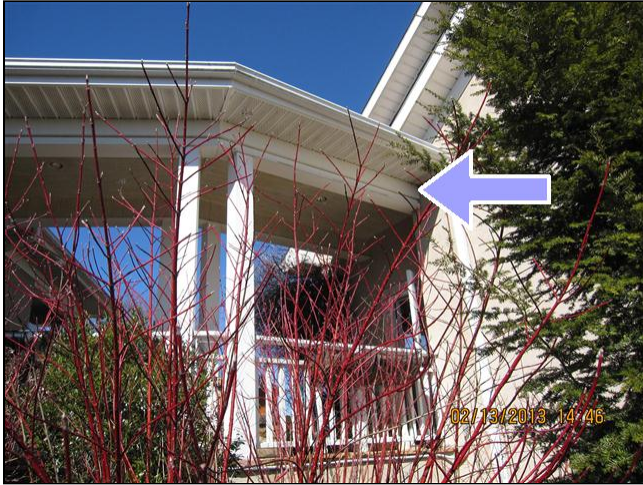
2.5 Item 1(Picture)

**2.5** Some areas need prep and paint along breezeway at top fascia trim (cosmetic).

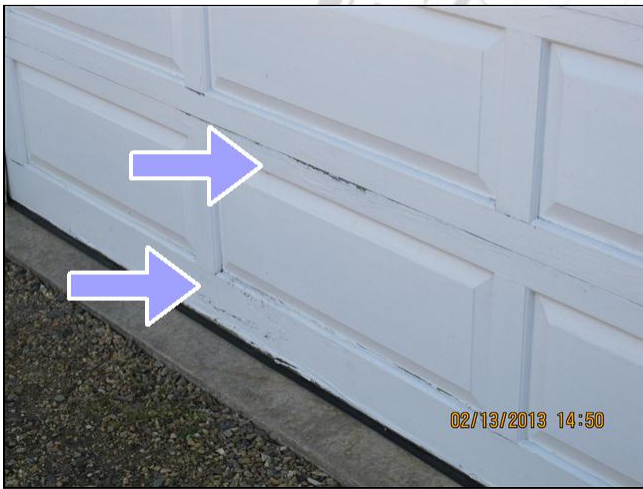
3.3 Item 1(Picture)

**3.3** Weathered needs prep and paint at Garage door.

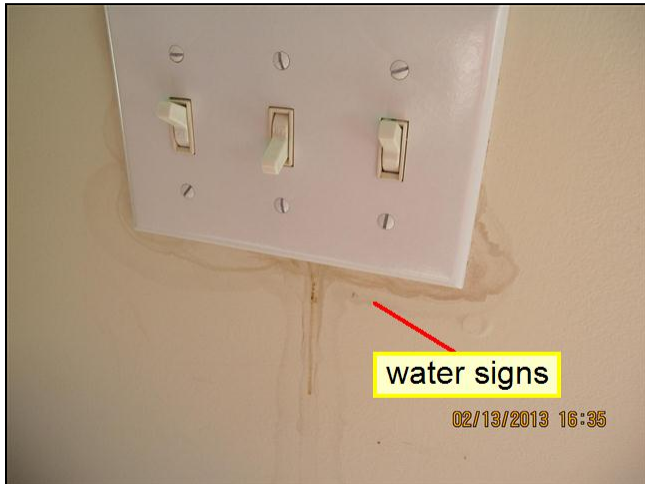
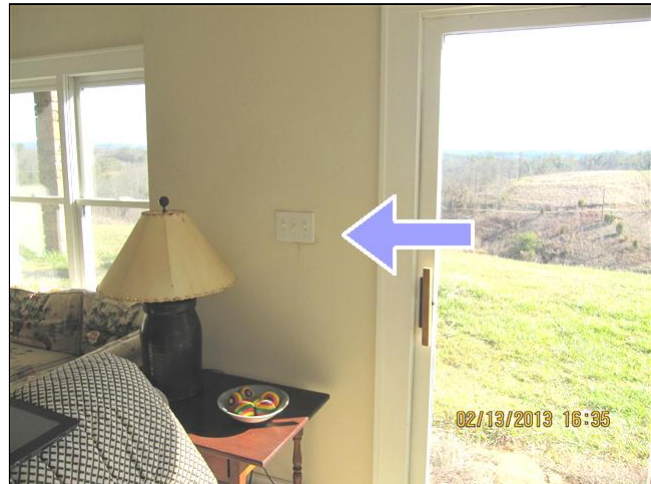
4.1 Item 2(Picture) wall switch Lower level

**4.1** Wall switch at lower level shows evidence of water getting in from outside? There is a light fixture in relation to this wall switch and perhaps water is getting in there? i recommend further investigation to determine location and correct.

Wall switch at lower level shows evidence of water getting in from outside? There is a light fixture in relation to this wall switch and perhaps water is getting in there? i recommend further investigation to determine location and correct.

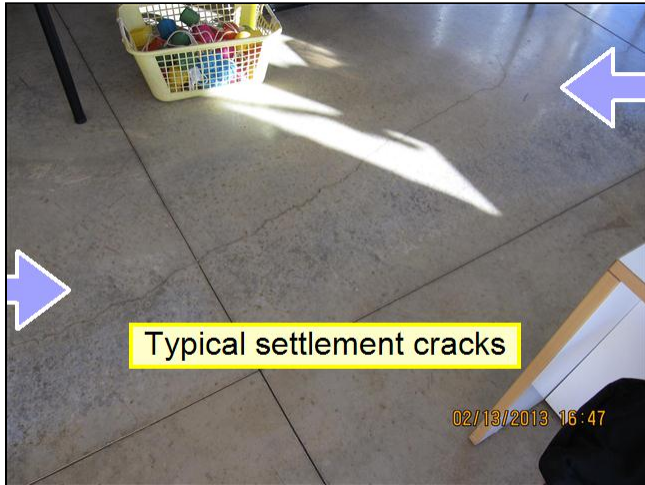
4.2 Item 1(Picture)

4.2 Lower level concrete has typical settlement cracks. We did not remove area rug or inspect underneath it.

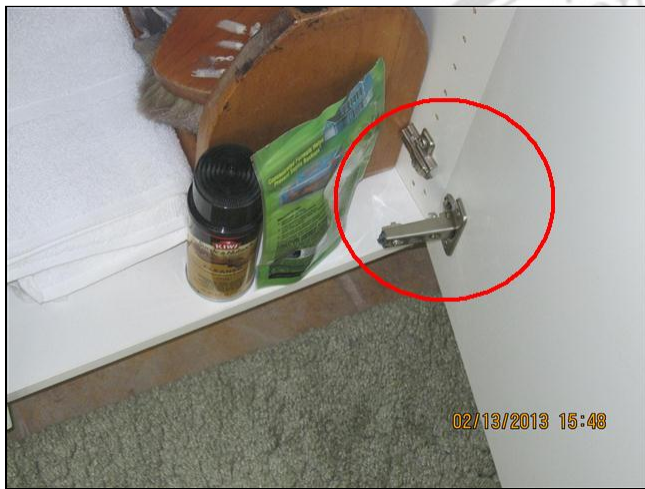
4.4 Item 1(Picture)

4.4 Hinge needs repair/replace at sink base in master bath.

Hinge needs repair/replace at sink base in master bath.

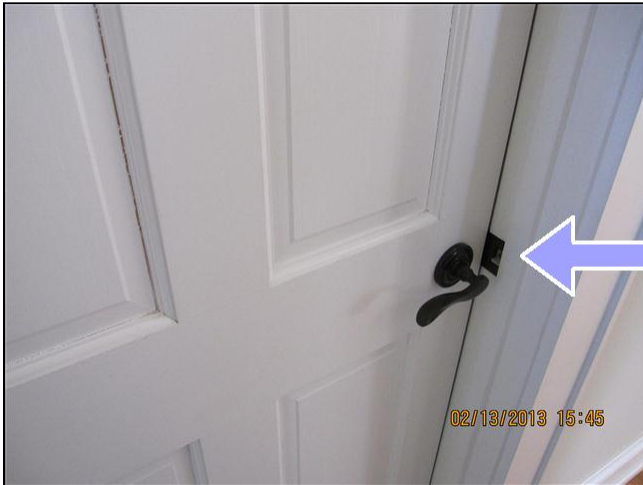
4.5 Item 1(Picture)

**4.5** Master bedroom closet door (His) will not latch easily, needs adjustment

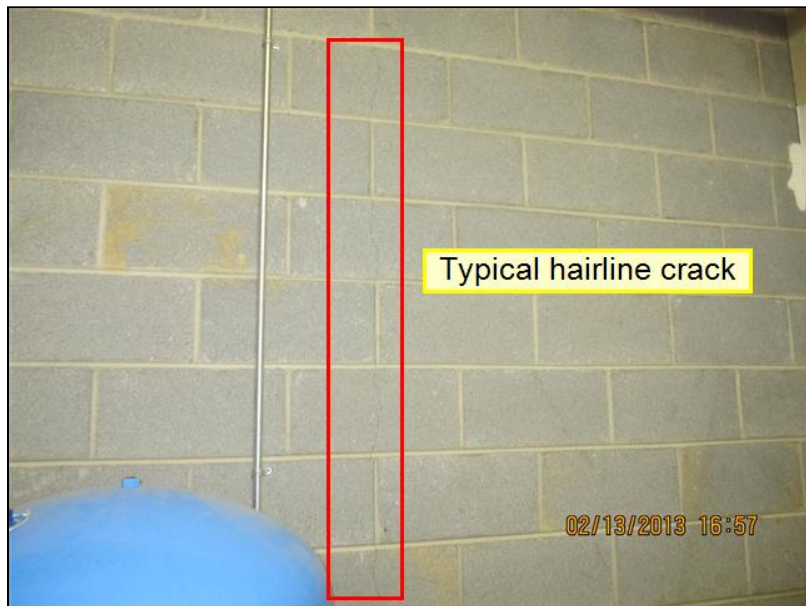
5.1 Item 1(Picture)

**5.1** Hairline cracks in wall (typical).

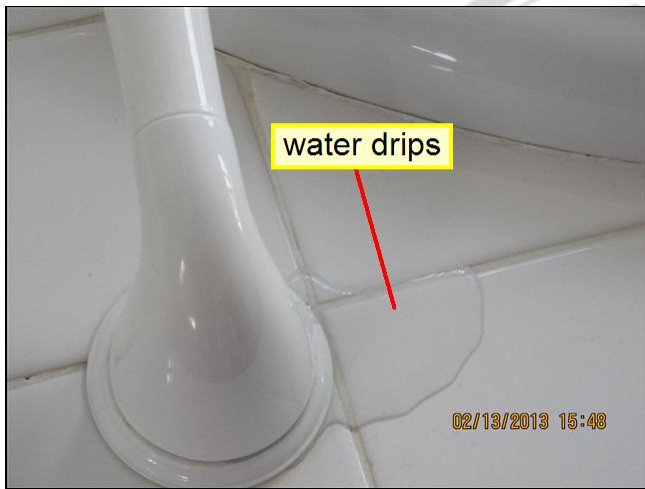
6.1 Item 1(Picture)

**6.1 (1)** Water drips from control knob on Jacuzzi brand tub. Also the lever to switch from spout to shower head works but feels weak when moved/turned and I am not sure if it is standard or loose? Recommend a plumber to inspect and repair as needed.

(1) Water drips from control knob on Jacuzzi brand tub. Also the lever to switch from spout to shower head works but feels weak when moved/turned and I am not sure if it is standard or loose? Recommend a plumber to inspect and repair as needed.

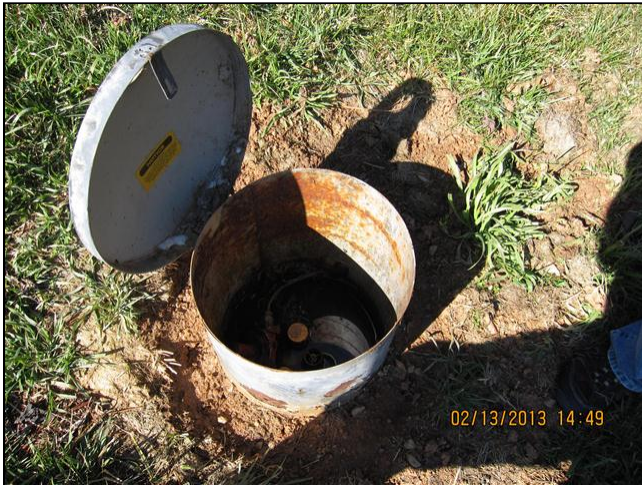
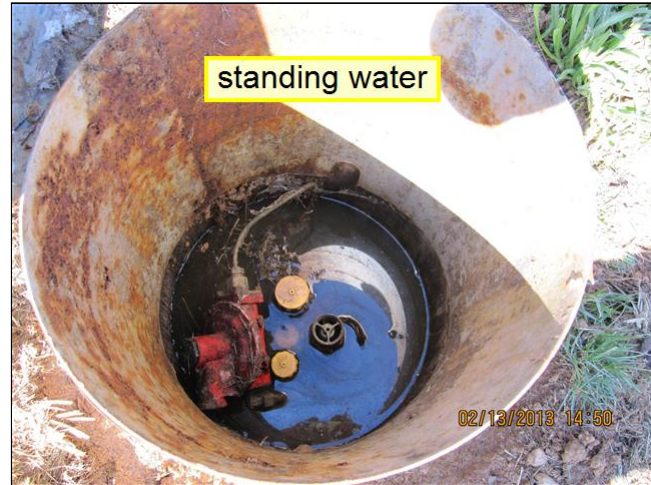
6.4 Item 1(Picture)

**6.4 (1)** Standing water should be removed and prevented from occurring at propane valves and meter access.

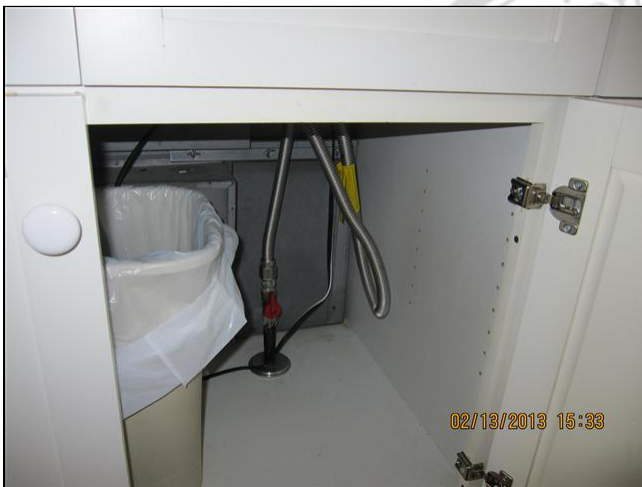
6.4 Item 3(Picture)

**6.4 (2)** Gas odor detected under range in kitchen and also upon entering into Equipment room downstairs where LP gas water heater is located. Note, there is a fresh air pipe connecting the equipment room to the outside air. Some energy pros may suggest that a mechanical fan would be more energy efficient than the passive vent installed.
